LARGE CALIBER WEAPON SYSTEMS LABORATORY

ENGINEERING REPORT LCR-E-1004

DUD INVESTIGATION OF
M69 ELECTRIC DETONATOR

11 APR 1978

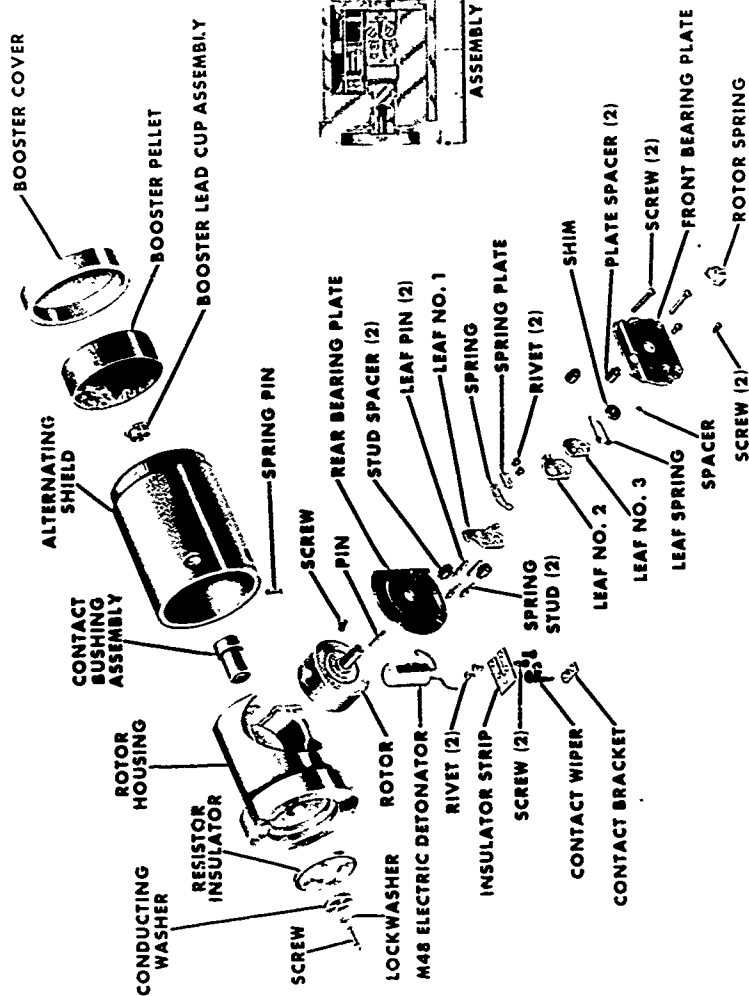
FIGURE 1

The M509A1 PIBD Fuze (Figure 1) is currently used in a number of HEAT Cartridges, specifically the 105MM M456A1; the 106MM M344A1 and the 90MM M431E2. Recently, the M456A1 and M344A1 Cartridges have been the subjects of in-bore premature malfunction investigations. As such, the M509A1 Fuze became an inherent part of those investigations with regard to its relationship as a potential contributor to the malfunctions. The culmination of the fuze investigation was the discovery of a number of M509A1 Fuze Technical Data Package inadequacies affecting both the safety and reliability of the fuzing system.

FUZE M509A1

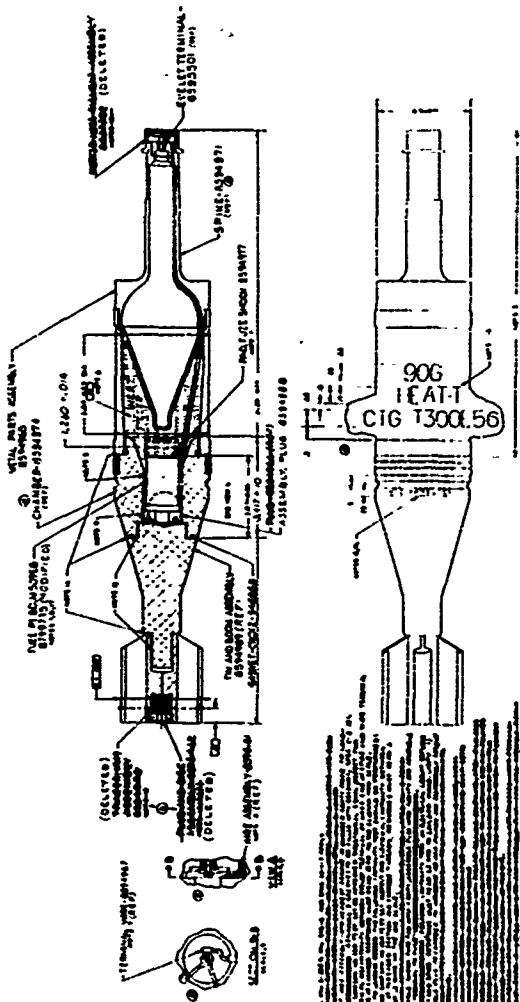
FIGURE 4

Another condition uncovered, was the location of the fuze in the projectile. The original version of the M456A1 Cartridge, was designed such that the fuze was completely encapsulated within the metal of the projectile body as shown for the 90MM Projectile in Figure 4. Only the output end of the fuze booster was exposed to the explosive filler. An engineering change implemented as the result of an earlier (1961) premature investigation modified the projectile assembly from a two piece to a one piece body design (Figure 5). This change shortened the overall projectile length and resulted in the fuze location being shifted such that over half the fuze is now encapsulated within the HE filler. The same situation also exists by design in the 106MM M344A1 HEAT Cartridge (Figure 6). Ultimately it was found that this fuze location combined with the weaker housing shield material and excessive output M48 Detonator, collectively resulted in the M509A1 Fuze not being detonator safe.

**105MM M456 HEAT PROJECTILE
W/M509A1 PIBD FUZE**
